## Lessons from Lighthouses: Shifting Sands, Coastal Management Strategies, and the Cape Hatteras Lighthouse Controversy

Orrin H. Pilkey, David M. Bush, and William J. Neal

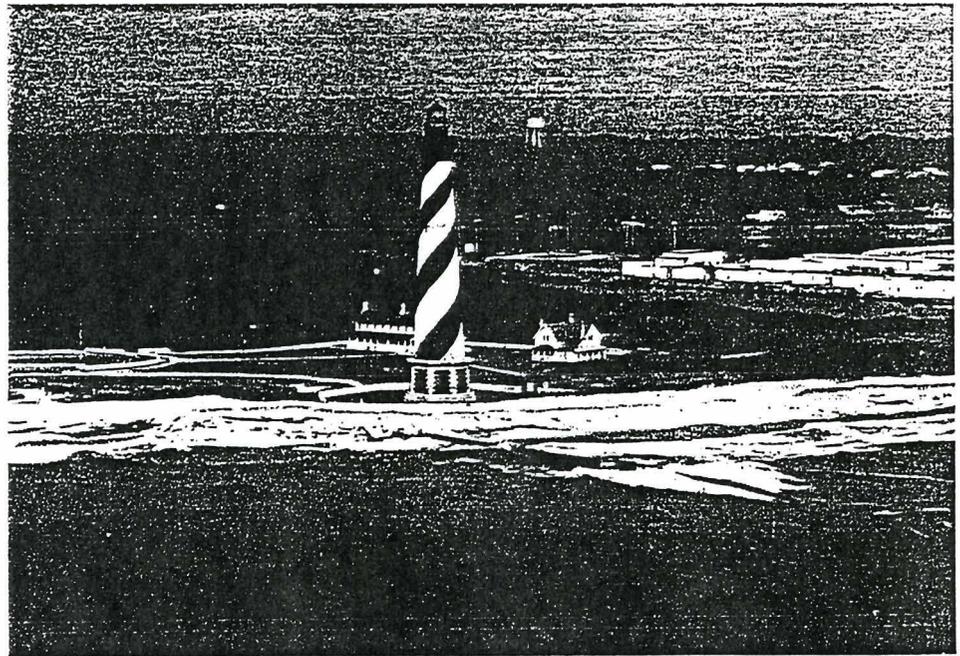
North Carolina's beautiful Cape Hatteras Lighthouse has warned mariners of the treacherous waters of Diamond Shoals since 1870. Three groins—the southernmost of which is shown here—and the sandbag revetment are part of a several-decades-long fight to hold back the sea. The "right" storm could have removed the lighthouse overnight. The pre-June 15, 1999 position of the lighthouse at the edge of the beach, shown here, is not typical of the building's history during which it sat well back from the beach.

point of Cape Hatteras. Following the construction of the groin field in 1969, the shoreline accreted within and north of the groins (aided by beach nourishment), whereas south of the groins (downdrift), erosion occurred. The U.S. Army Corps of Engineers study provided very generalized longshore transport estimates, but longshore transport is exceedingly difficult to model mathematically and certainly even harder to measure in nature.<sup>11</sup> Using wave power data and long-term averages, the Corps has claimed that the southerly and northerly sediment transport rates may be on the order of 650,000 cubic yards per year and 300,000 cubic yards per year, respectively, resulting in a net southerly transport of about 350,000 cubic yards per year.

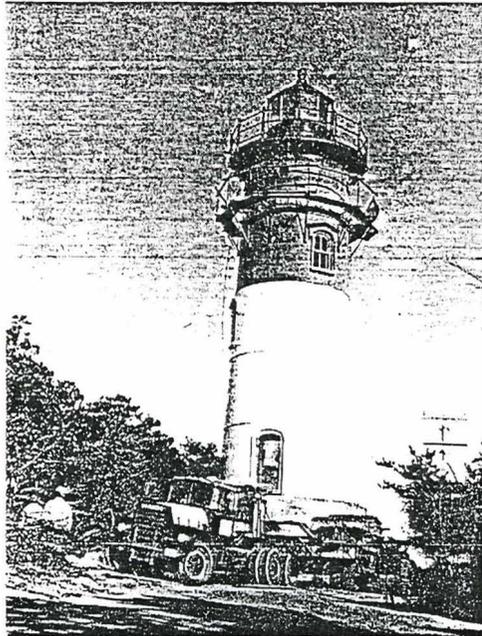
The Nauset Lighthouse, Eastham, Massachusetts, is shown in the process of being moved on November 16, 1996. (Courtesy of Shirley Sabin, Nauset Light Preservation Society)

The technology to move large buildings exists, and the modern relocation of three New England lighthouses provides examples. The 2,000-ton Block Island Southeast Lighthouse, Rhode Island, was moved 245 feet inland in 1993. In 1996, the Cape Cod Highland Lighthouse, noted earlier, was moved 450 feet to a position close to its original distance from the bluff edge. Also in 1996, the Nauset Lighthouse in Eastham, Massachusetts, was moved 300 feet inland

from its former location near the edge of a 60-foot high eroding bluff face. If only some property owners in nearby Chatham had been so prudent as to move their houses before they fell into the sea.

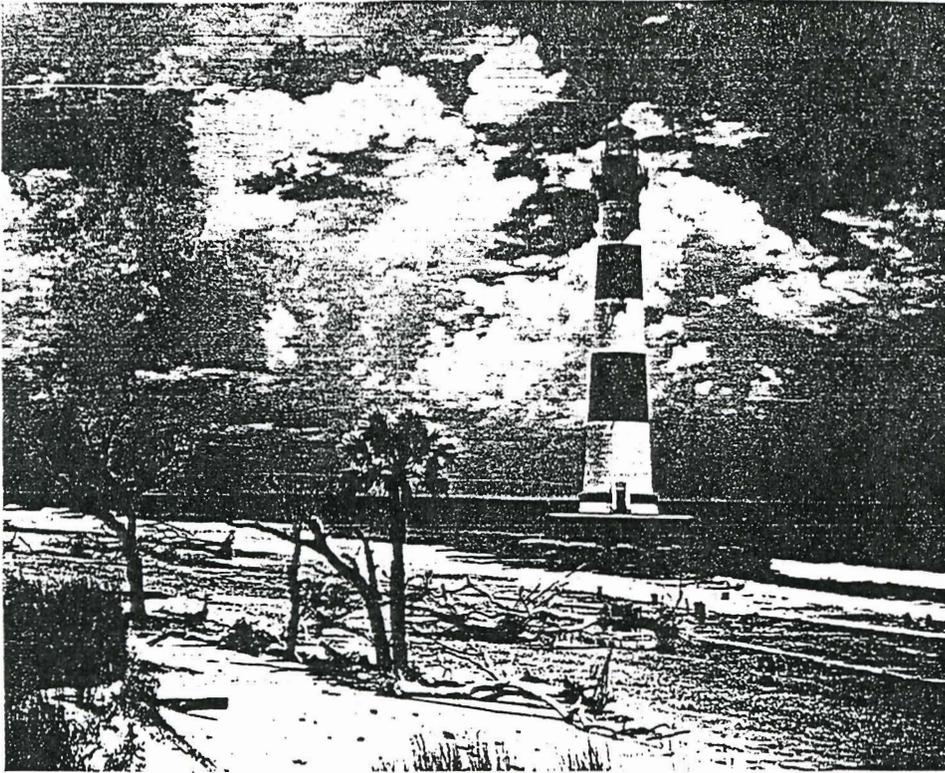
Looking to the northeast from Morris Island between 1940 and 1950, one would have seen the Morris Island lighthouse, also known as the Charleston Light, going out to sea. (Photograph by George W. Johnson from the collection of W. J. Keith)

The famous Morris Island Lighthouse in South Carolina, was left standing in the sea in the 1940s as a result of rapid shoreline retreat caused by the construction of the Charleston Harbor jetties built in the late 1890s.<sup>2</sup> Dynamic Sand Island, at the mouth of Mobile Bay in Alabama presents a similar example, but drowning of the lighthouse there is the result of natural island migration. Sand Island migrated west-northwest, leaving the static lighthouse marking the former island position.

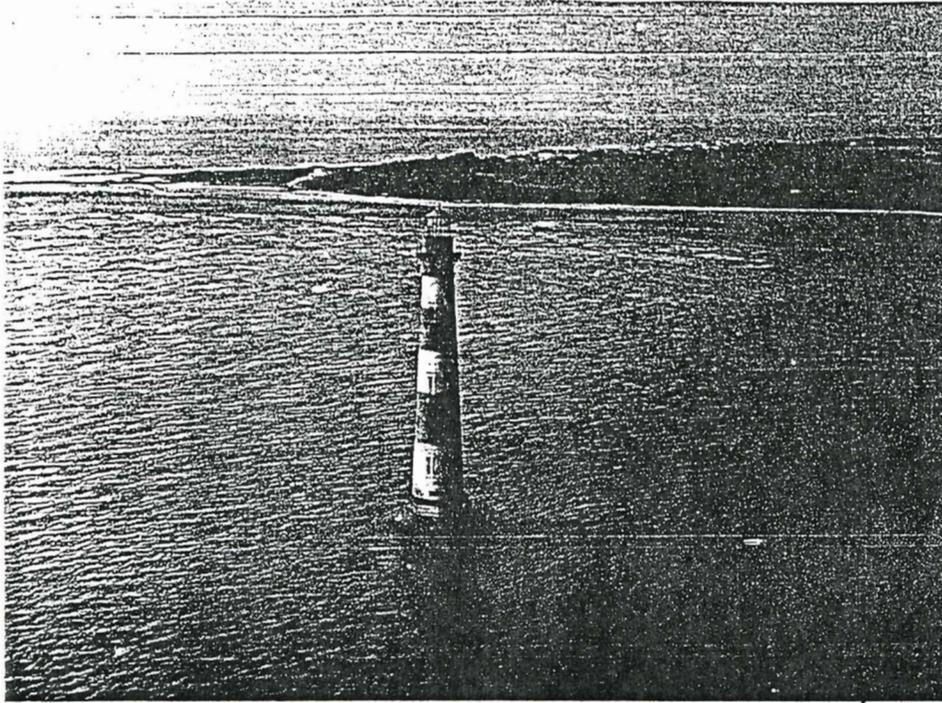
The Morris Island Lighthouse today as seen looking approximately south toward Folly Island; Morris Island is out of the picture to the right. (Courtesy of Gered Lennon)

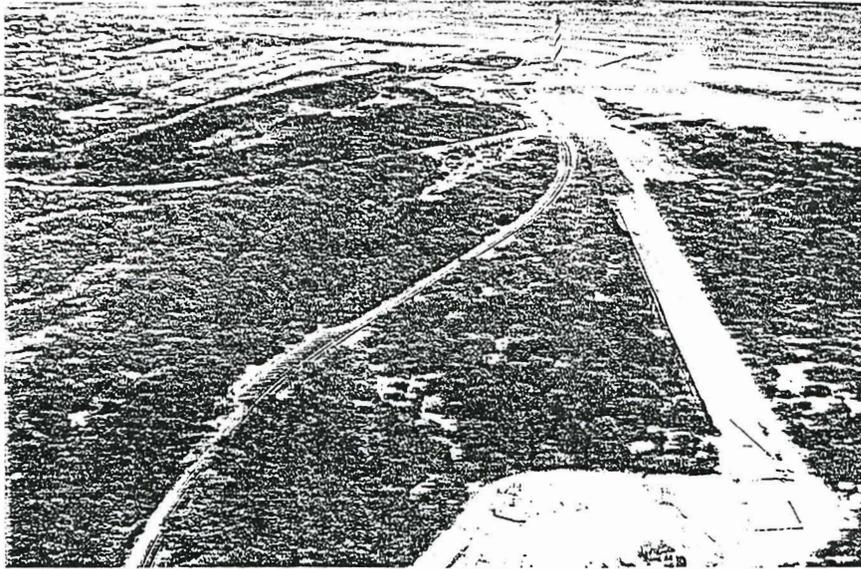
The Cape Hatteras Lighthouse on June 15, 1999, at the beginning of the runway along which it would be moved to its new location approximately one-half mile from the shoreline. (Photograph by Mike Booher)

new location on July 9. Eight companies were involved in the heavily planned move. The roadway for the move consisted of gravel 24 inches deep covered by thick steel mats. The lighthouse tower was lifted by 112 heavy jacks to a base of 20 steel beams and moved on seven steel tracks. As one building mover noted, the first few inches of the move were the most difficult. Push jacks were used to move the entire frame and lighthouse at a rate of one foot per hour. (A plan to pull the structure along the rails with cables had been eliminated because of the possibility of sudden jerks and stops.) The maximum rate of lighthouse movement was approximately 300 feet per day. Throughout the move, the structure was heavily monitored by using tilt, acceleration, and strain meters. When it reached its destination the Cape Hatteras Lighthouse had been moved approximately one-half mile from its original location.
